Flood Control Project Maintenance**2011 Structure Summary Report****Overall Unit and Item Ratings****DWR Sacramento Maintenance Yard****Cache Creek Setting Basin Weir And Drainage Structure**

Flood Control Project Maintenance
2011 Structure Summary Report
Overall Unit and Item Ratings

Flood Control Project Maintenance**Unit Cover Sheet****2011 Structure Inspection Results****DWR Sacramento Maintenance Yard**

**Flood Control Project Maintenance
Levee Inspections**

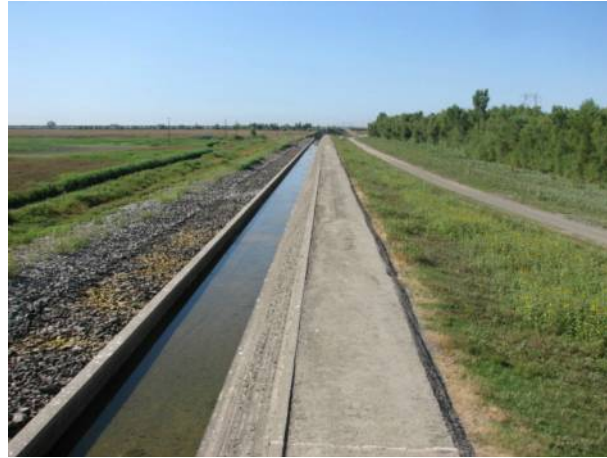
johngw_t_20110727_011.jpg

The photo was taken from the top of the levee on the north side.

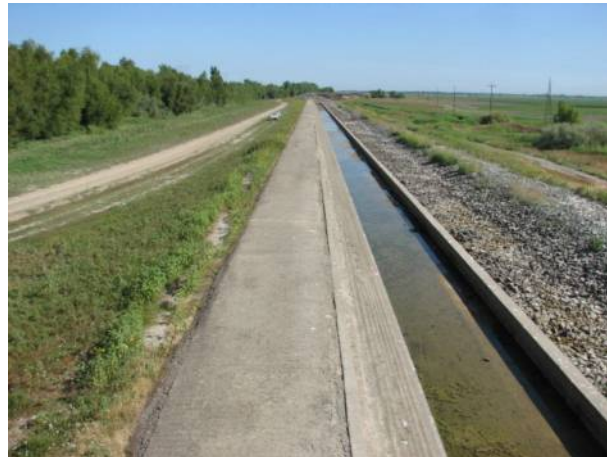
johngw_t_20110727_012.jpg

The photo was taken from the top of the levee on the south side.

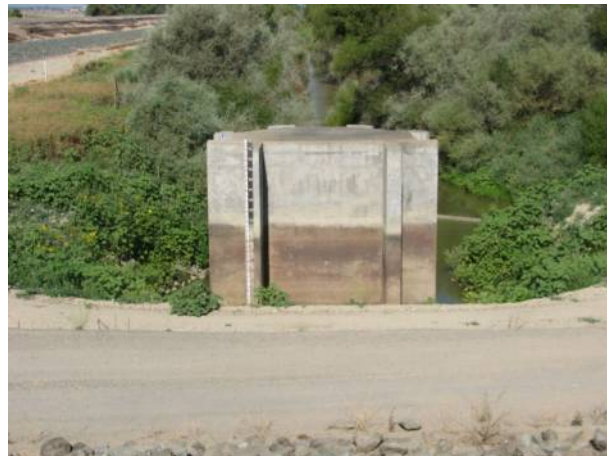
johngw_t_20110727_013.jpg

The backside of the low flow intake structure.

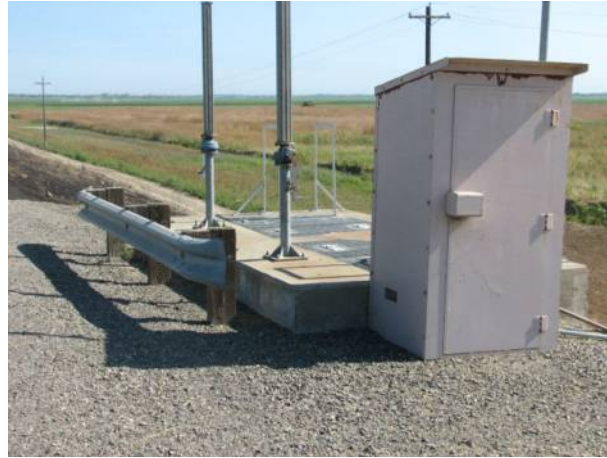
johngw_t_20110727_014.jpg

The control structure with the manual gates for the low flow structure.

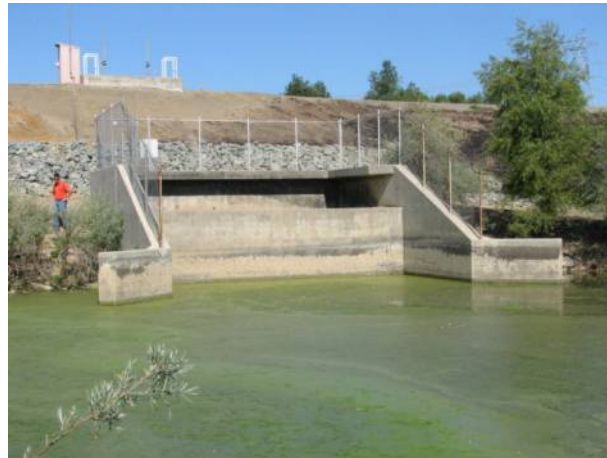
johngw_t_20110727_015.jpg

The outlet for the low flow structure.

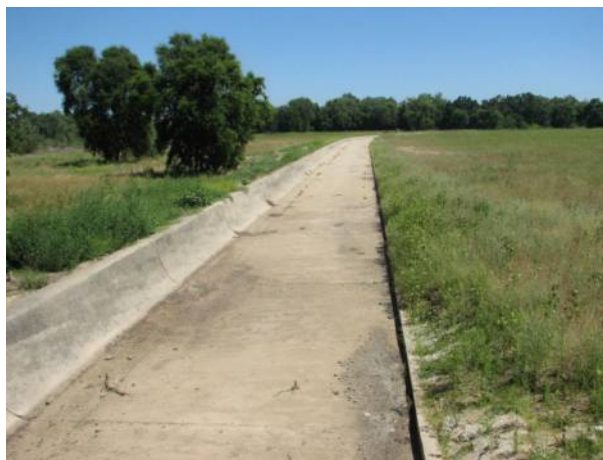
Johngw_t_20110726_001.jpg

This view is from the West end of Fremont Weir.

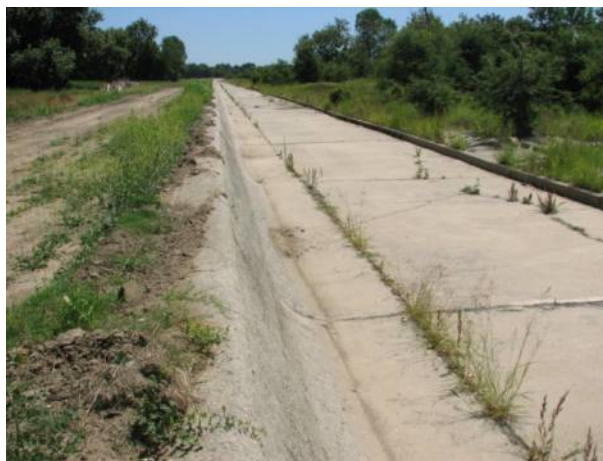
Johngw_t_20110726_003.jpg

This is looking East at the fish ladder. There are some minor vegetation in the cracks through the weir.

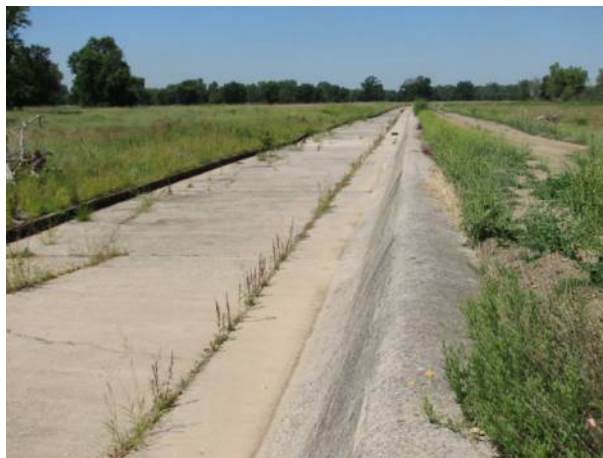
Johngw_t_20110726_004.jpg

This is looking West at the fish ladder.

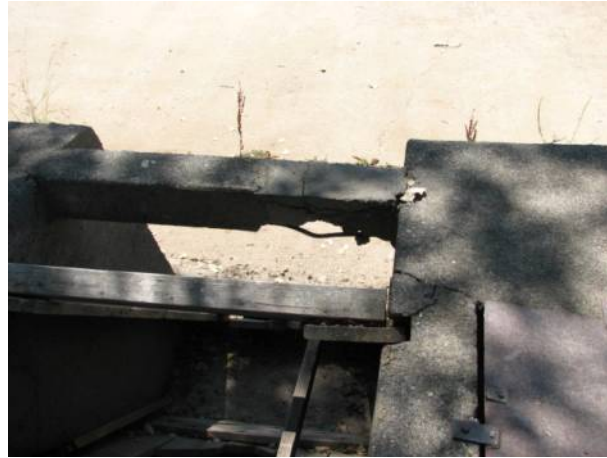
Johngw_t_20110726_005.jpg

The concrete beams across the fish ladder shows rebar.

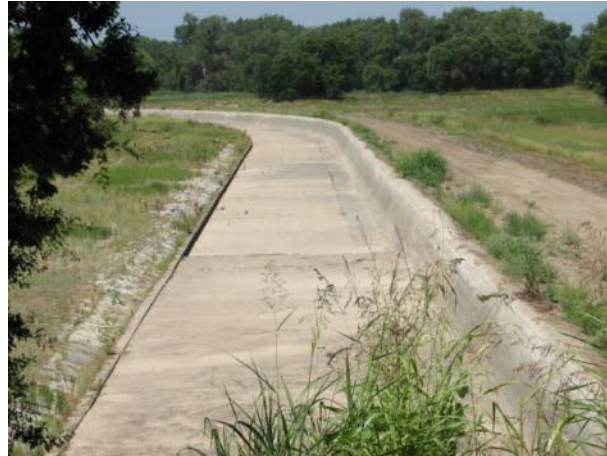
Johngw_t_20110726_006.jpg

The view is from the East end of Fremont Weir.

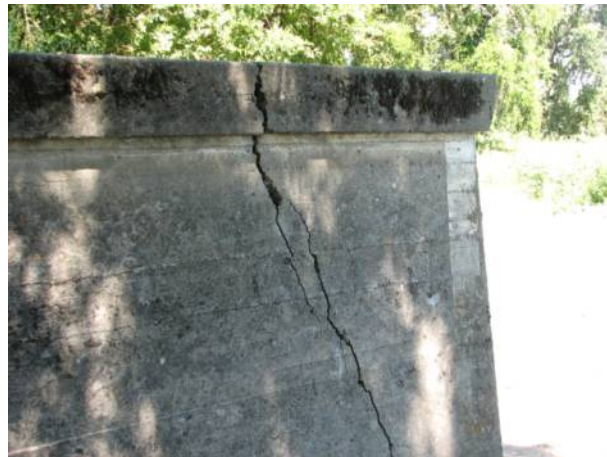
johngw_t_20110822_007.jpg

The photo is of the crack in the West end abutment. It does not effect the function of the weir. The crack is about 1" wide at the top. It does need to be repaired.

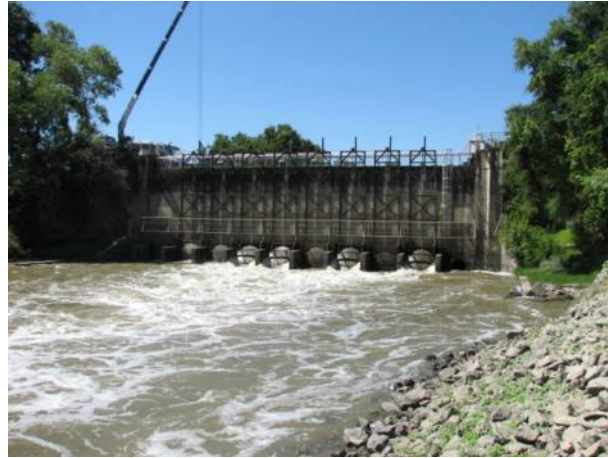
johngw_t_20110727_007.jpg

The photo was taken from the north levee.

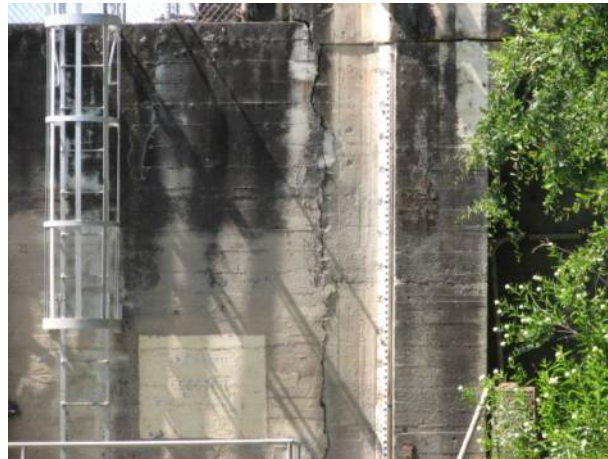
johngw_t_20110727_008.jpg

The crack at the north end of the structure has not changed from last year. Continue to monitor the crack and repair as necessary.

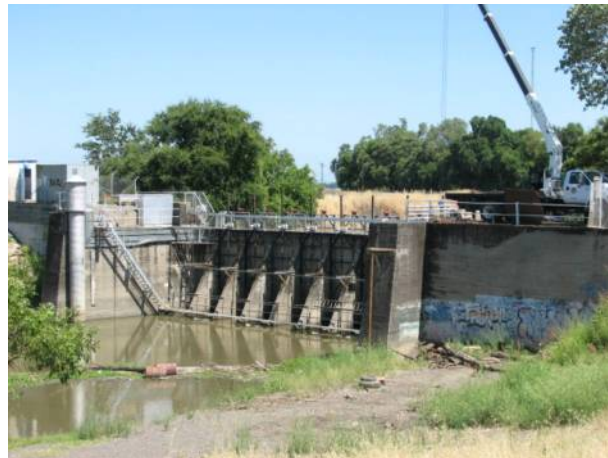
johngw_t_20110727_009.jpg

The photo was taken from the south levee. This is a view of the inlet side of the structure.

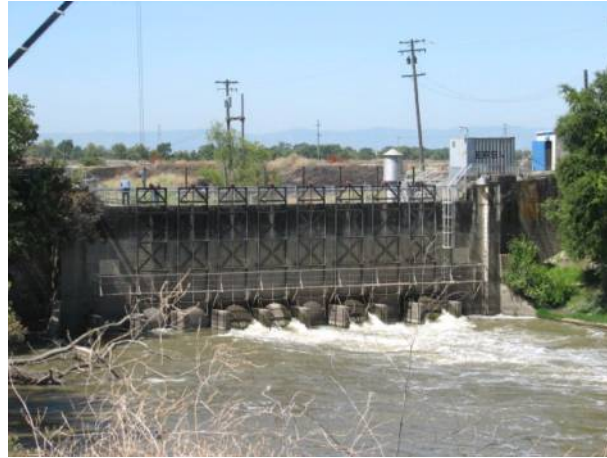
johngw_t_20110727_010.jpg

The photo is from the south levee.

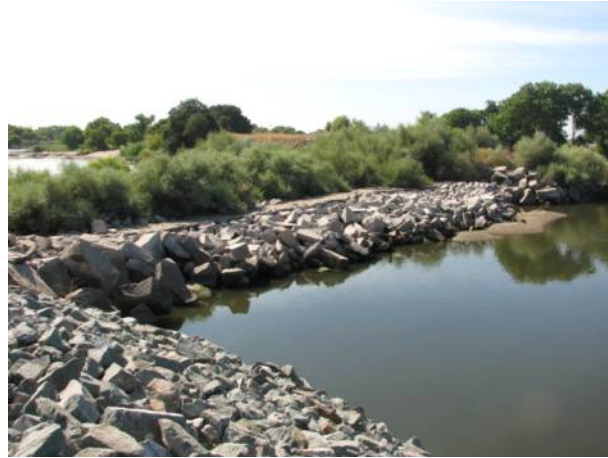
johngw_t_20110728_019.jpg

The photo was taken from the right back of the dam.

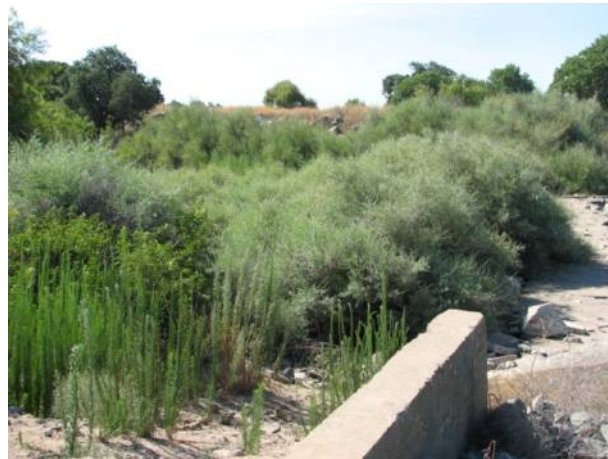
johngw_t_20110728_020.jpg

The photo shows the willows that grow right up to the face of the dam.

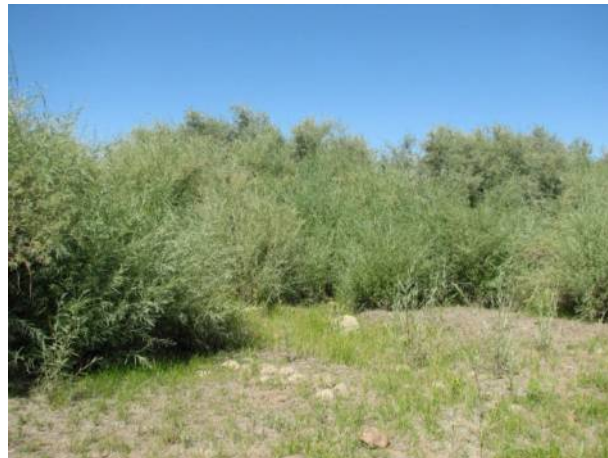
johngw_t_20110728_021.jpg

This the view from the San Joaquin River looking towards the dam. With the height of the willows you cannot see the dam.

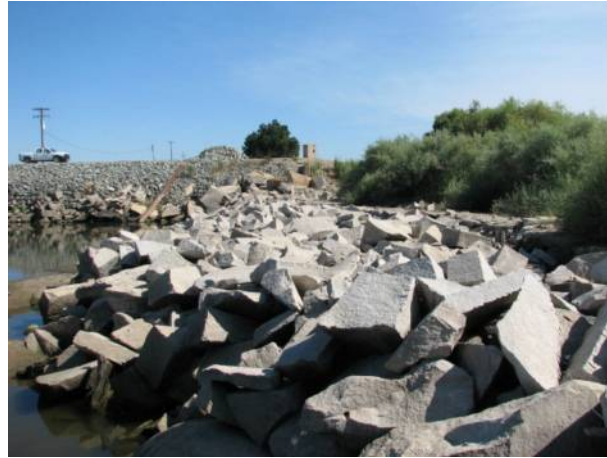
johngw_t_20110728_022.jpg

The photo is from the left bank of the dam.

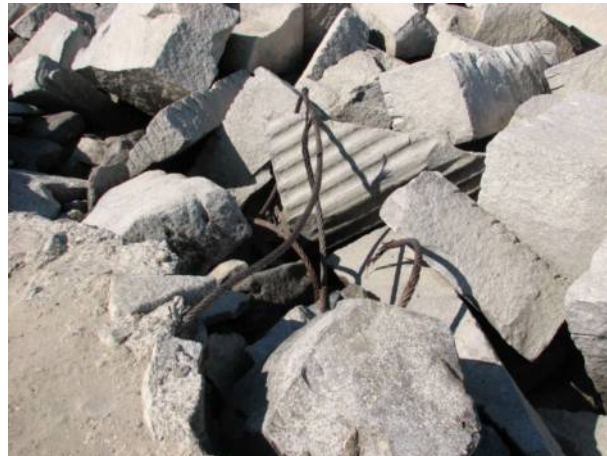
johngw_t_20110728_023.jpg

Cable inbedded into the concrete that use to go around the piles.

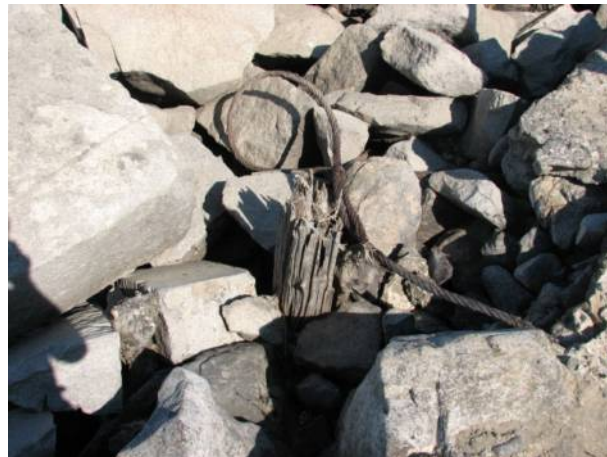
johngw_t_20110728_024.jpg

More cable and piles that could be a safety hazard.

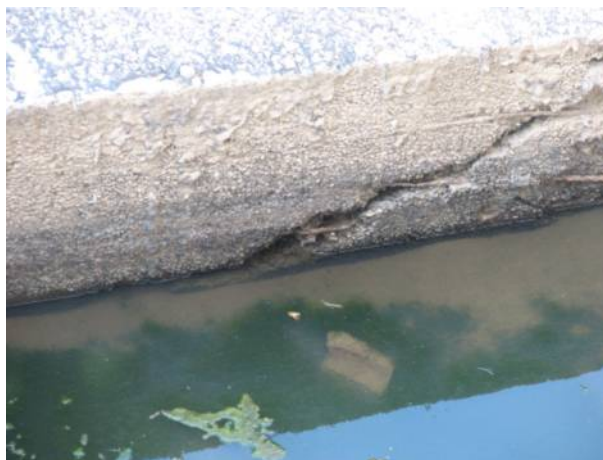
johngw_t_20110727_016.jpg

This is in bay 1 out flow side of the defuser.

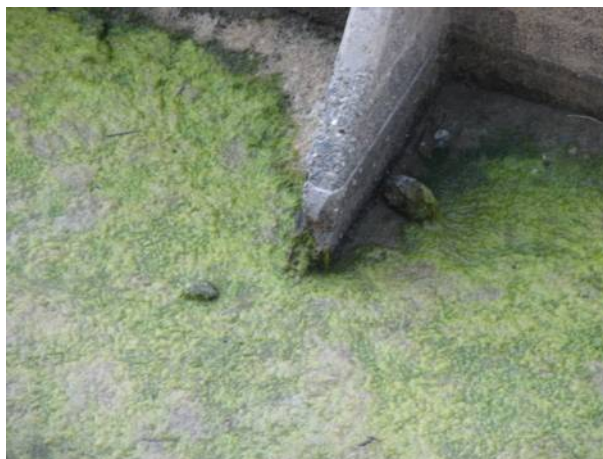
johngw_t_20110727_017.jpg

This in bay 3 minor damage to be repaired.

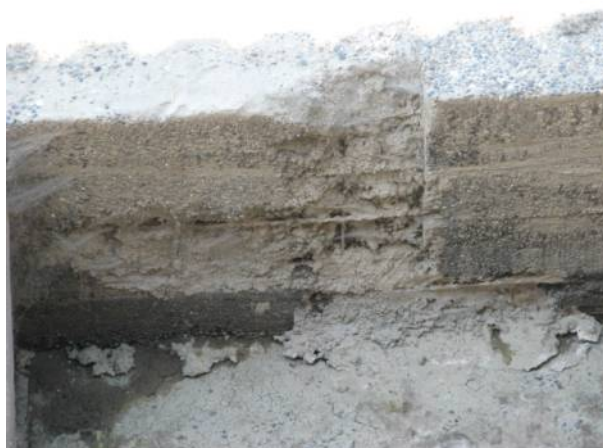
johngw_t_20110727_018.jpg

This is bay 14 out flow side of the defuser.
